**PB90-910406  
NTSB/AAR-90/06**

**AIRCRAFT ACCIDENT REPORT**

**UNITED AIRLINES FLIGHT 232  
McDONNELL DOUGLAS DC-10-10  
SIOUX GATEWAY AIRPORT  
SIOUX CITY, IOWA  
JULY 19, 1989**

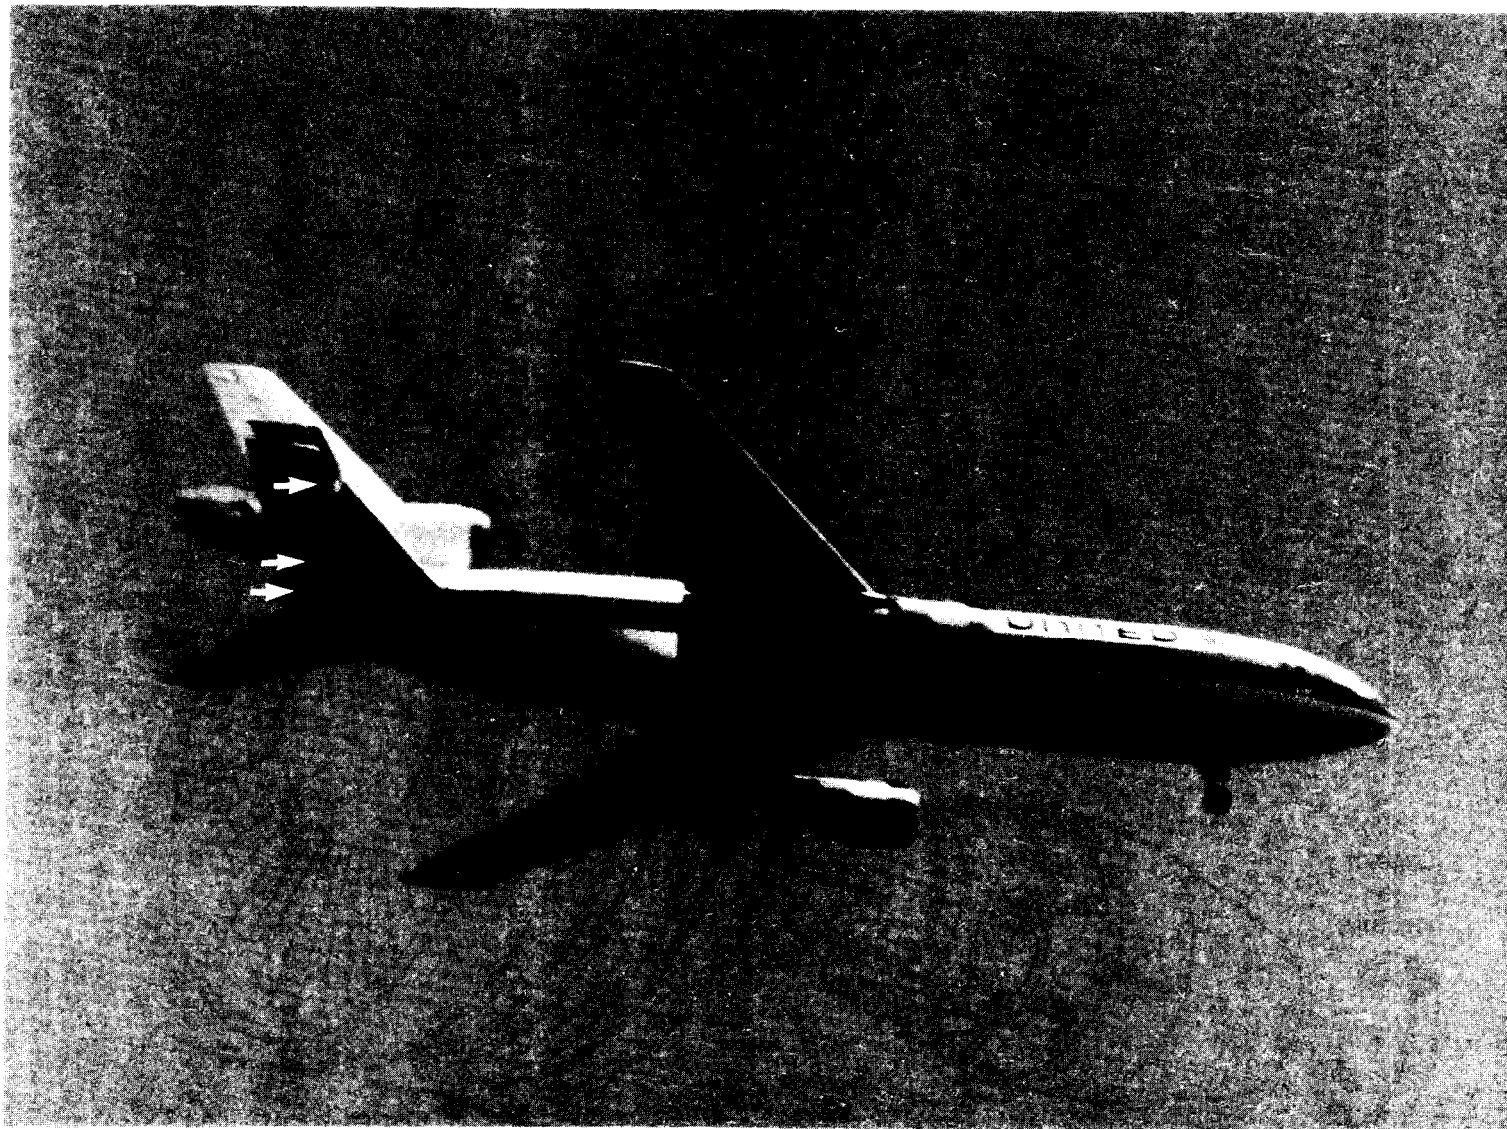
Photographs of the airplane were taken by observers on the ground during its final approach to Sioux Gateway Airport. They showed that the No. 2 engine fan cowling and the fuselage tail cone were missing. The remainder of the No. 2 engine appeared intact. Postcrash examination of the wreckage revealed that the No. 2 engine fan rotor components forward of the fan forward shaft, as well as part of the shaft, had separated from the engine in flight. (See figures 3 through 5).

Figure 3. -- Photo (C. Zellmer) taken while flight 232 was approaching Sioux Gateway Airport. Arrows indicate damage to the right horizontal stabilizer. It is also evident that the No. 2 engine fan cowl door and the tail cone are missing.

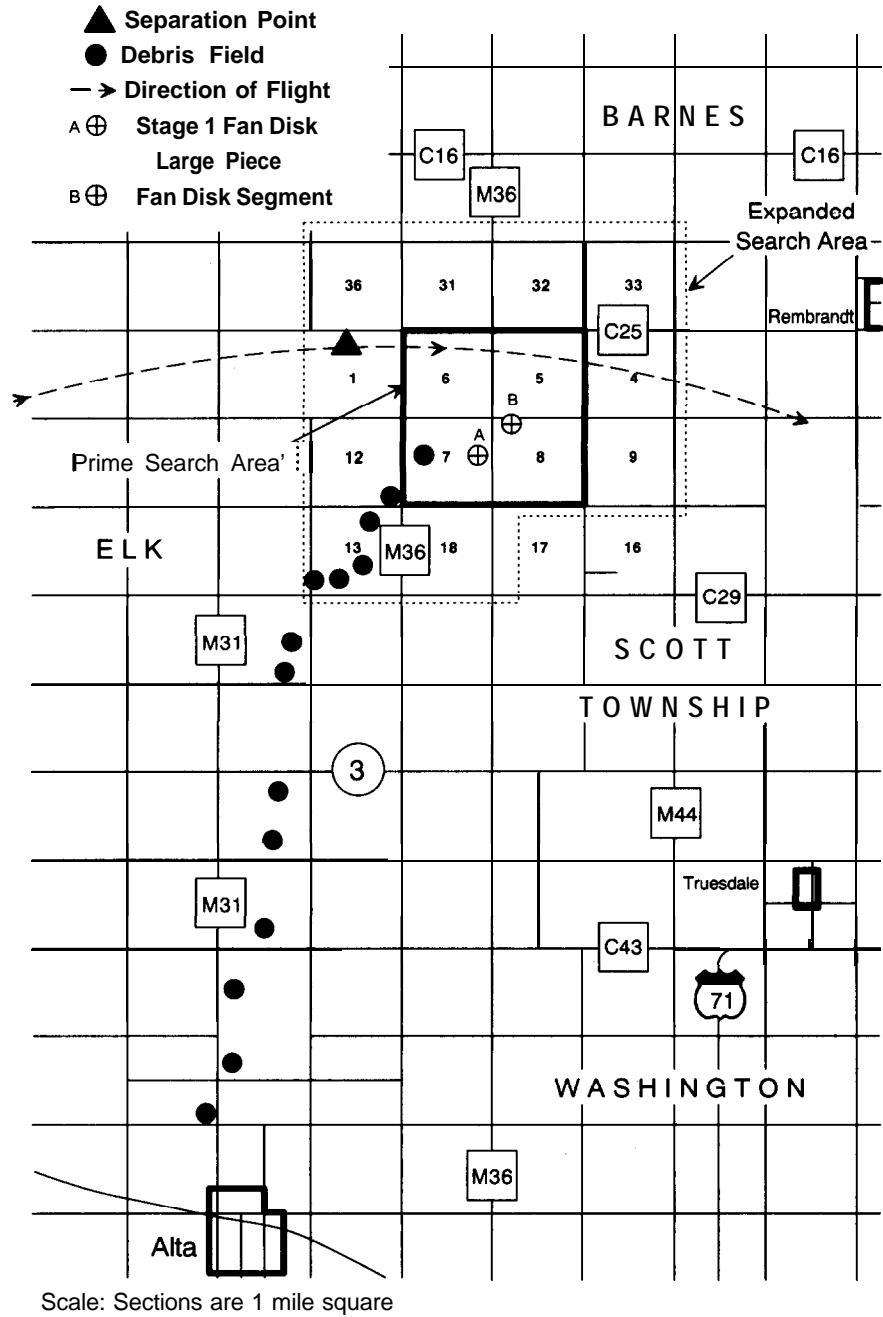
Also found near Alta soon after the accident were parts of the tail engine adapter assembly, consisting of adapter ring and bellmouth assemblies, an anti-ice pneumatic tube, a starter air tube, three cowl hold-open rods, two hydraulic system accumulators from the No. 2 engine-driven hydraulic pumps, fan blade fragments, two pieces of insulated metal braid-covered hydraulic hose clamped together, and a segment of aluminum material broken out of the large structural "banjo" forging from the airplane inlet duct structure.

About 3 months after the accident, parts of the No. 2 engine fan disk were found in farm fields near Alta. There were two sections that constituted nearly the entire disk, each with fan blade segments attached. These parts were initially taken to the GEAE facility in Evandale, Ohio, for examination under the direction of the Safety Board. The small segment was later transported to the NTSB Materials Laboratory in Washington for further evaluation. (See section 1.16, Tests and Research).

Figure 11. --Trajectory information/Alta debris field.

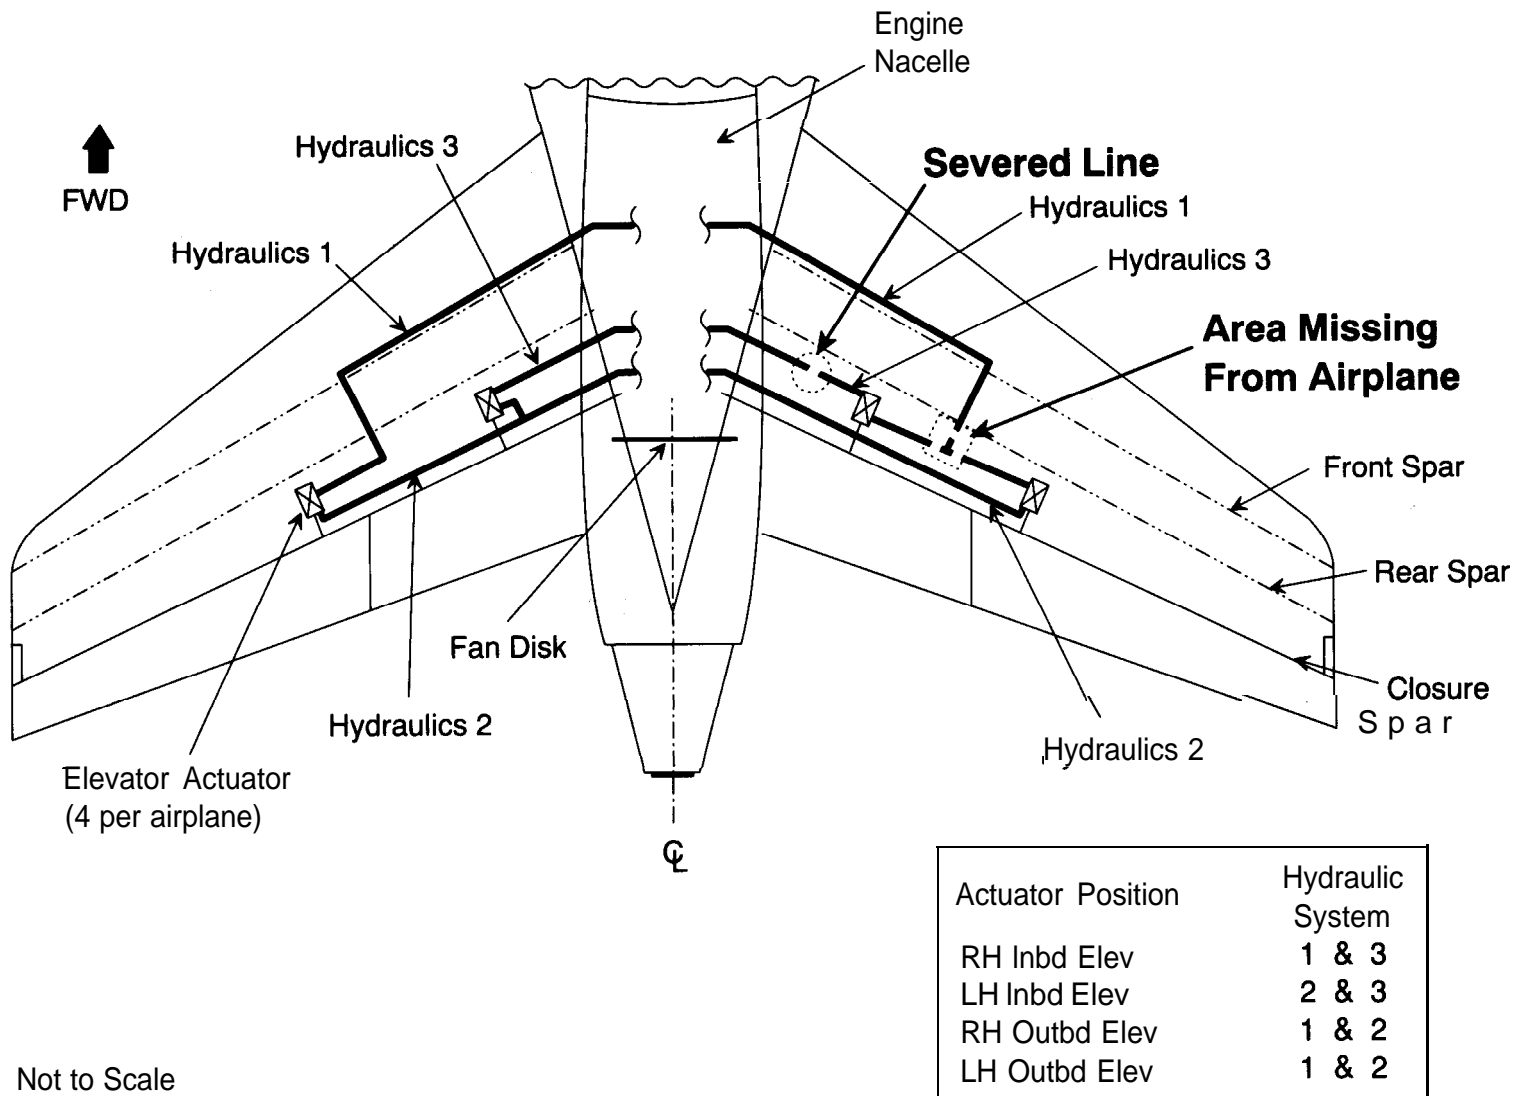
Figure 14. --N1819U, planform of horizontal stabilizer hydraulic system damage.

the upper and lower surfaces in the area of the severed line. The pressure line was severed with a gap of approximately 2.5 inches. The return line had penetrated the horizontal stabilizer and had separated from the adjacent fitting. Material adhering to severed areas of the damaged hydraulic lines of the No. 3 hydraulic system was identified by X-ray energy dispersion examination as titanium alloy. The entry hole where the object passed through the top skin and doubler was 5.5 inches by 2.25 inches and roughly rectangular. The hole size did not match the dimensions of any piece of the stage 1 fan disk; however, the hole size and shape were comparable to the dimensions of a fan blade base platform.

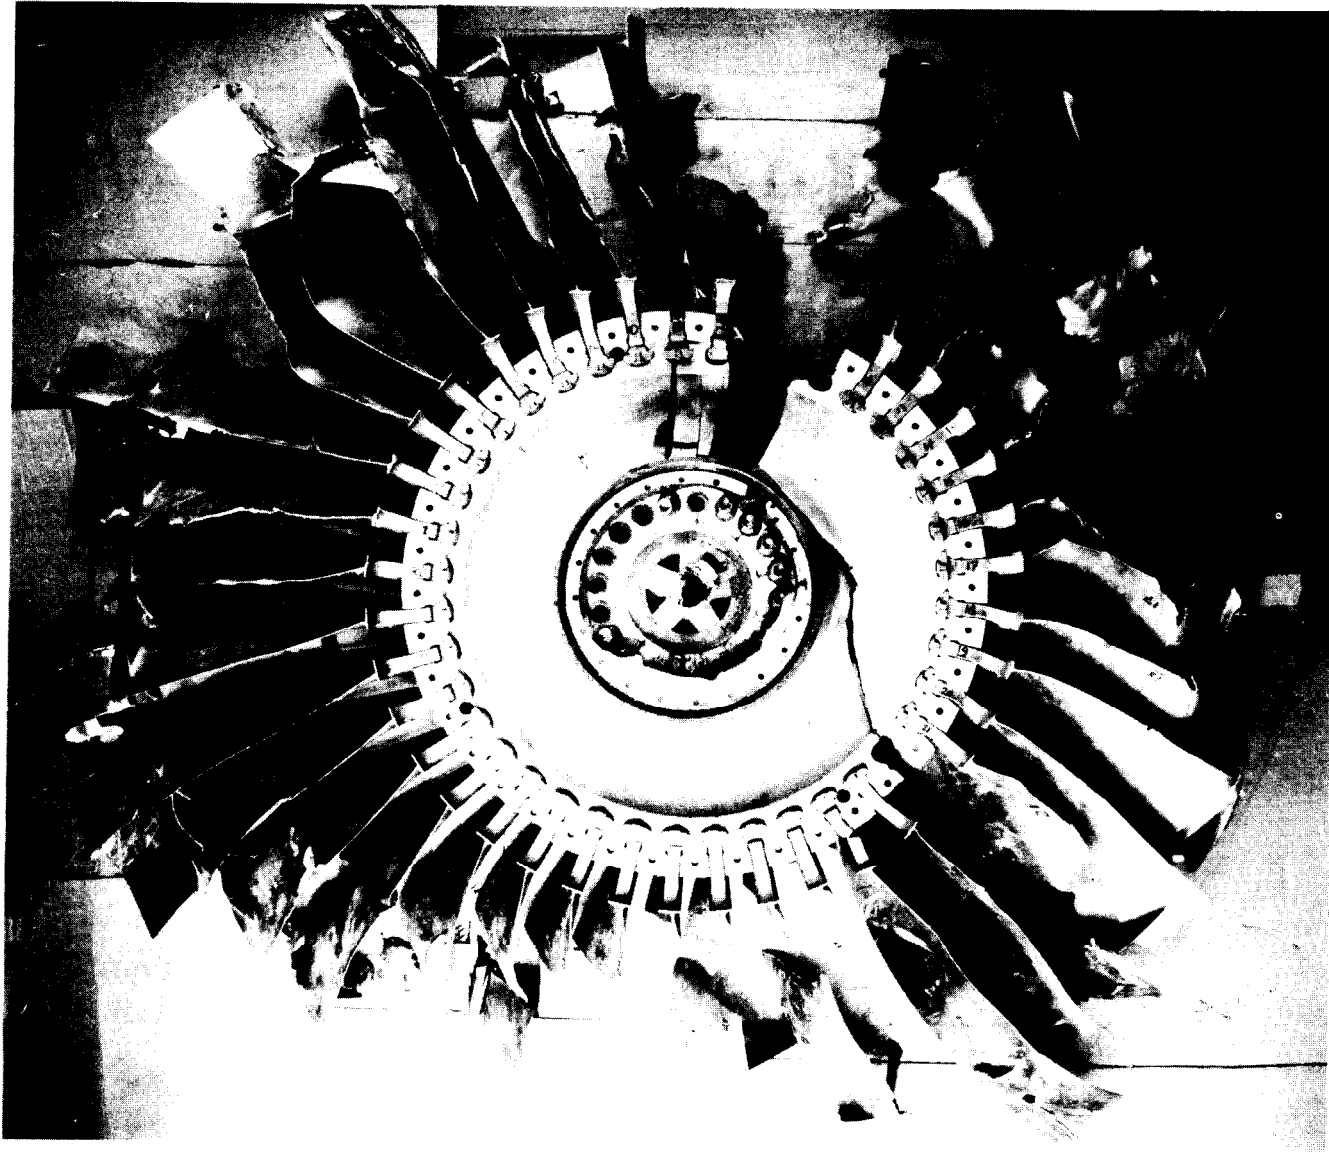
In mid October 1989, about 3 months after the accident, two pieces of the No. 2 engine stage 1 fan disk, with attached blade pieces, were found in corn fields near Alta, Iowa. The two pieces comprised the entire separated disk, with the exception of one dovetail post, which was not recovered. Figure 18 shows the **reconstructed** pieces of the disk after the larger disk piece had been cut during the metallurgical evaluations. The gap between the smaller and larger piece does not represent missing material but is a result of **mechanical** deformation that occurred during the disk separation. The disk contained two principal fracture areas, resulting in about one-third of the rim separating from the remainder of the disk. One of the fracture areas progressed largely circumferentially through the web and rim. The other was on a near-radial plane, progressing through the bore, web, disk arm, and rim. Features on the circumferential fracture were

Figure 18. -- No. 2 engine stage 1 fan disk (reconstructed with blades).

typical of an overstress separation stemming from multiple origin areas in the radius between the disk arm and the web. The near-radial fracture surface also contained overstress features over most of its surface. However, on this break the overstress features stemmed from a preexisting radial/axial fatigue crack region in the bore of the disk. Figure 19A shows the fatigue region on the bore.

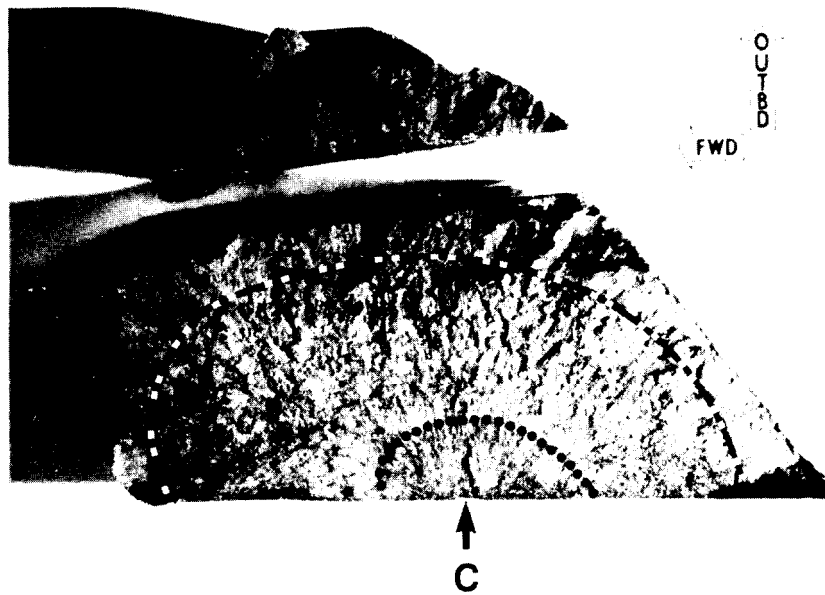
Figure 19A.--Fatigue crack fracture area cut from the bore of the smaller piece of the separated stage 1 fan disk. The fatigue crack extends from the cavity (arrow "C") to the dashed line position. The discolored portion of the fatigue crack is between the cavity and the dotted line. Magnification: 2.26X.

portion of the inclusion at the fatigue origin. However, between the cavity bottom and a radial distance of 0.025 inch outboard of the bore surface, areas with brittle fracture features and a lack of fatigue striations were found intermixed among more ductile-appearing bands with fatigue striations. The zone with a mixture of brittle features and fatigue striation areas correlated with the enriched alpha microstructure surrounding the stabilized-alpha core of the inclusion.

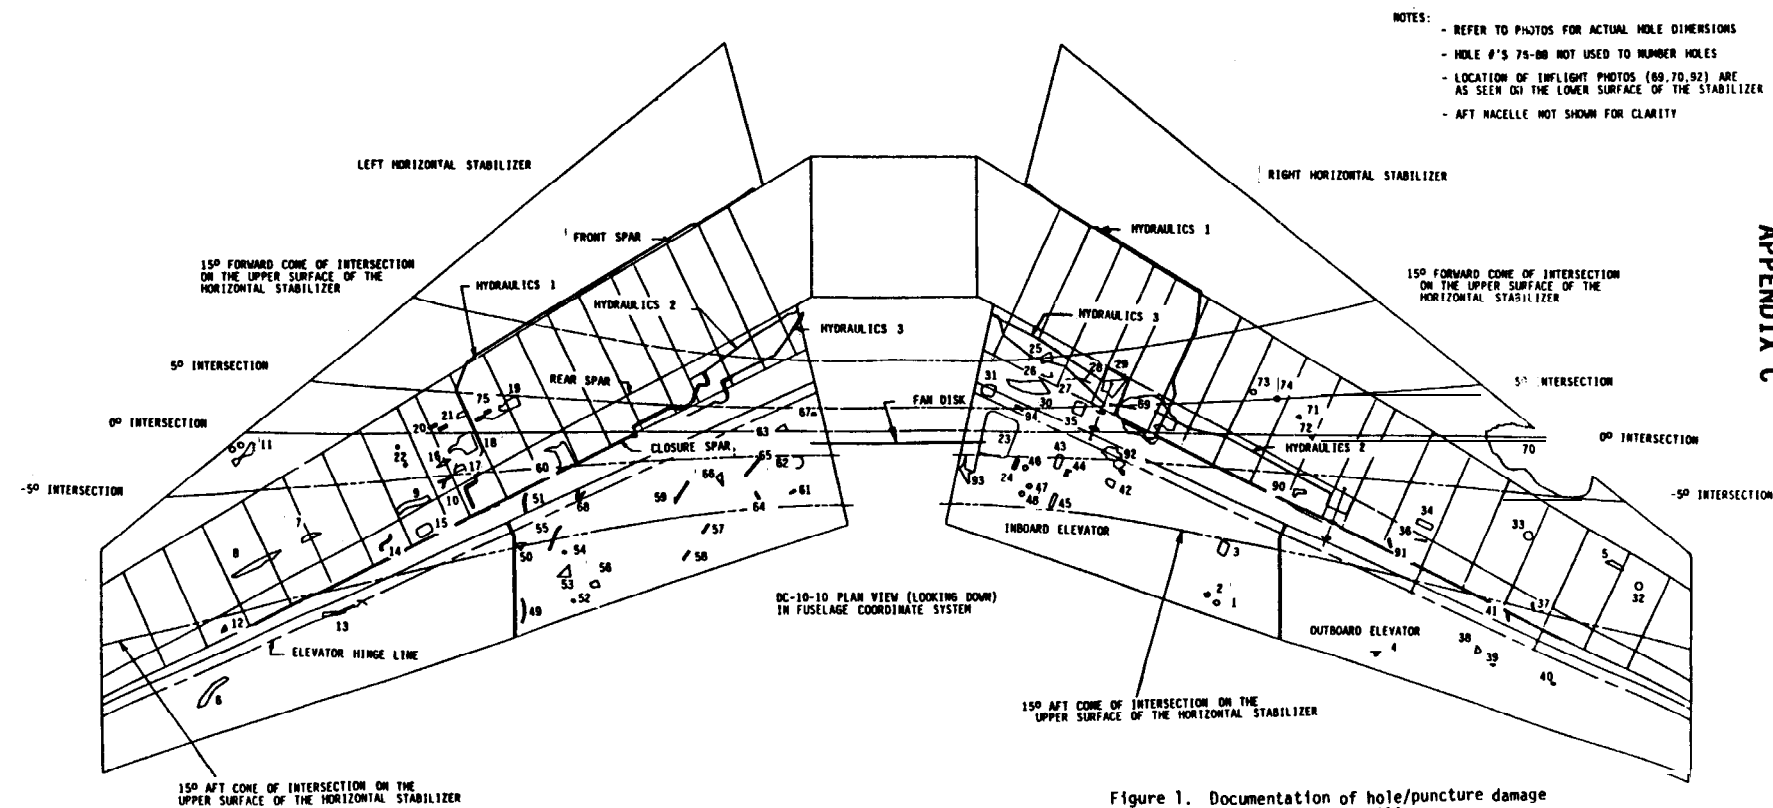
# HORIZONTAL STABILIZER DAMAGE DIAGRAM

Four punctures on the vertical stabilizer were noted as probable fragment damage prior to ground impact. Documentation of hole/puncture damage to the horizontal stabilizers is contained in Appendix C. There were 79 punctures recorded from fragment damage and one large hole, about the same size as the large piece of recovered fan disk. The flight control surfaces were recovered in the aircraft wreckage and had varying degrees of damage that could have occurred before or after impact.
